**PRELIMINARY ASSESSMENT/
VISUAL SITE INSPECTION**

**ESTAD PRODUCTS, INC.
(FORMERLY ATI, INC. - CONTINENTAL DIVISION)
DANVILLE, ILLINOIS
ILD 007 833 833**

FINAL REPORT

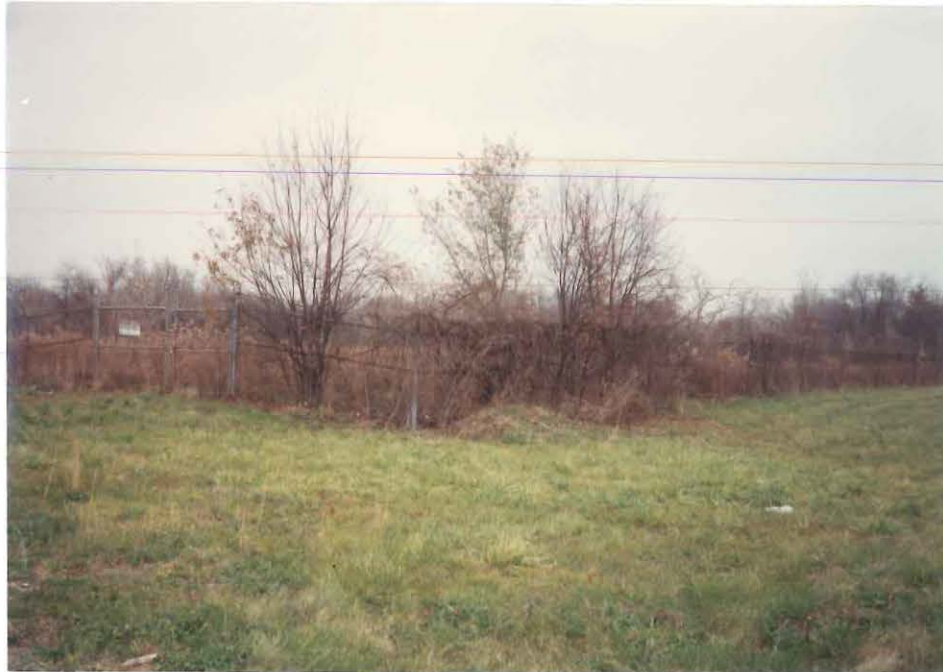
Observations: At the time of the VSI, this unit had been filled in and was covered by thick vegetation and there was no visible evidence of catwalks associated with the unit (see Photo No. 1). There were no visible stains or evidence of a release in the area of this unit.

Location: SWMU 1

Recommendations: Dynamac recommends the facility conduct soil and ground water sampling to determine the extent of contamination from possible past releases of hazardous constituents, particularly volatile organic compounds.

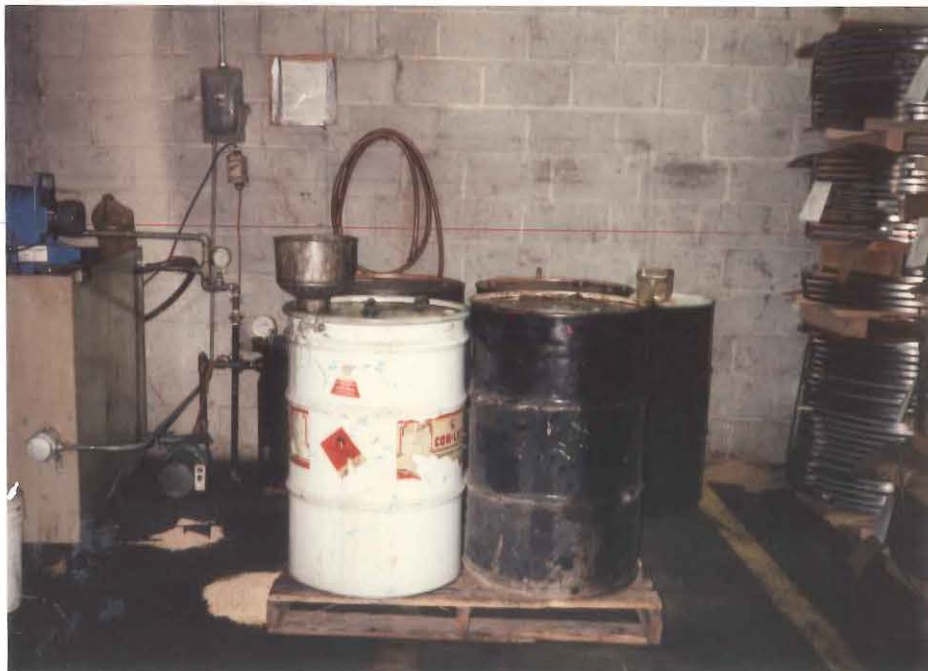
Observations: Dynamac observed the unit, which contained four 55-gallon steel drums of nonhazardous waste oil with water (see Photo No. 2). The concrete floor in the area of the unit was stained in some places with an oily substance. There were no visible cracks in the concrete floor of this unit.

Location: SWMU 2

Recommendations: Dynamac recommends no further action for the unit at this time.

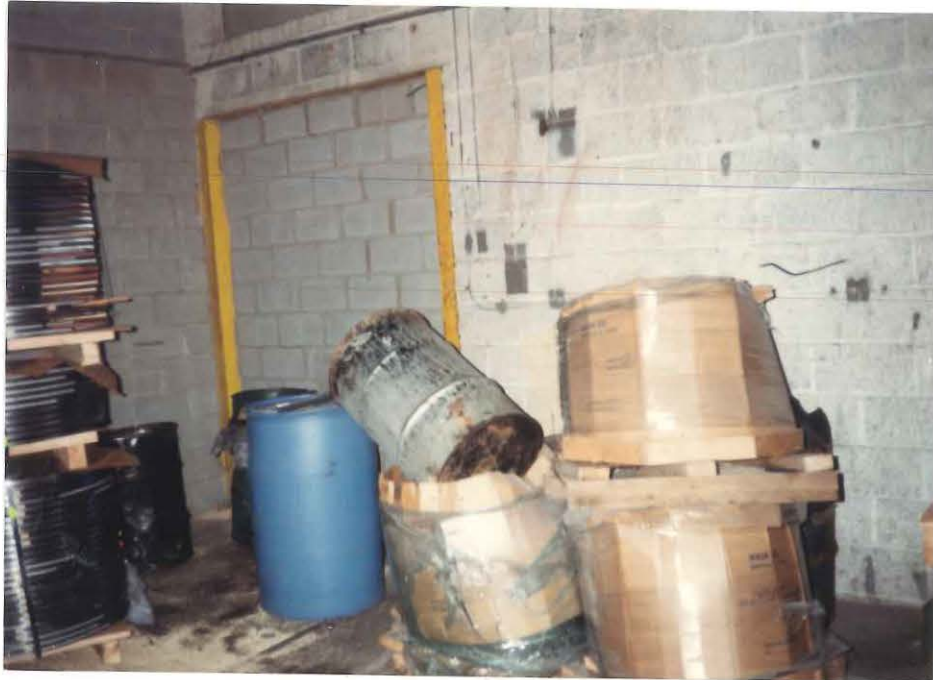
Date of Startup:	This unit began operation around 1984.
Date of Closure:	This unit is active.
Wastes Managed:	This unit manages nonhazardous waste oil with water. Estad ships this waste off site for treatment and recycling.
Release Controls:	This unit manages waste indoors in closed 55-gallon steel drums on a concrete floor with no floor drains. There are no other release controls associated with this unit.
History of Documented Releases:	No releases from this unit have been documented.
Observations:	Dynamac observed the 75-square-foot area which did not contain any waste at the time of the VSI. The area did contain a closed empty drum and some raw materials (see Photo No. 3). The concrete floor in the area of this unit was stained in some places with an oily substance. There were no visible cracks in the concrete floor.

Location: SWMU 3

Recommendations: Dynamac recommends no further action for the unit at this time.

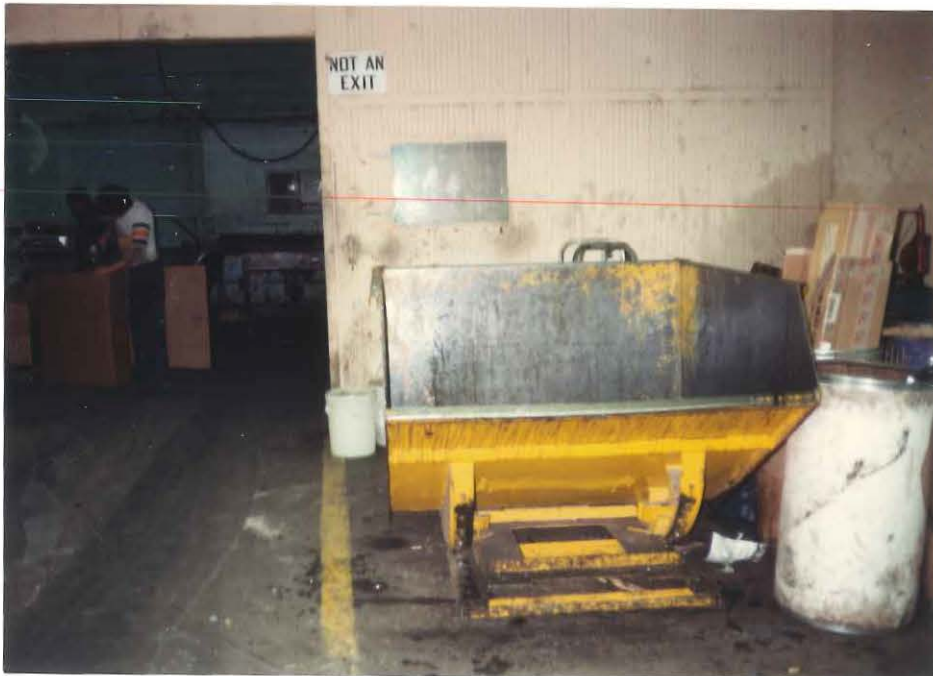
Conclusions: The Scrap Steel Hoppers consist of about fifteen steel hoppers located indoors on a concrete floor with no floor drains. The units are used to manage nonhazardous scrap steel. At the time of the VSI, the concrete floor in the area of one of these units was stained with an oily substance; however, Dynamac did not observe any cracks in the floor near these units. No releases from these units have been documented. The potential for a release to all environmental media from these units is low.

Location: SWMU 4

Recommendations: Dynamac recommends no further action for these units at this time.

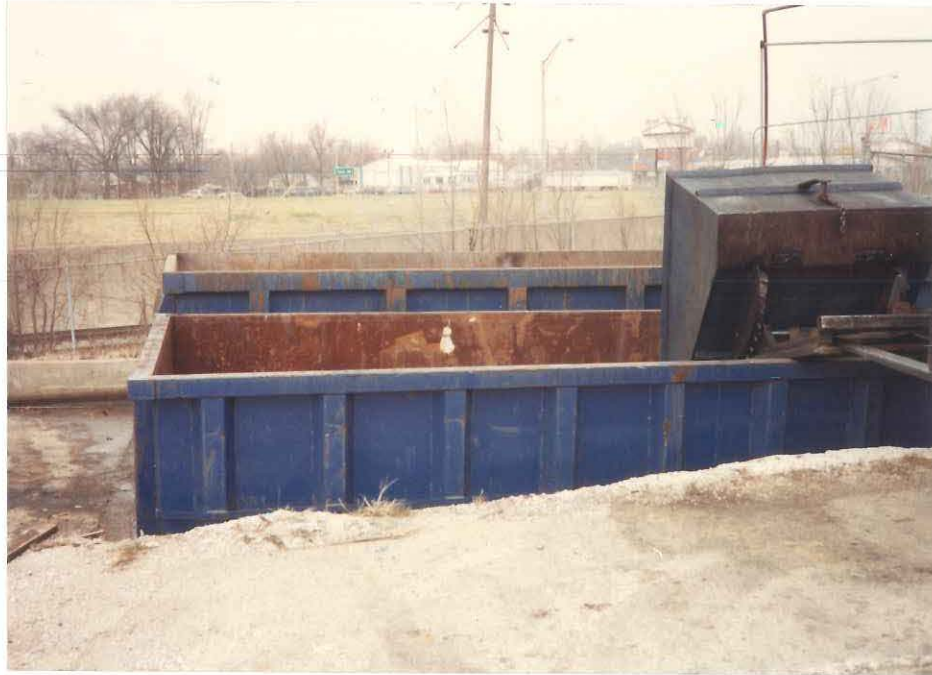
Dynamac observed the two rolloff boxes at this unit; there were no visible stains or evidence of release (see Photo No. 5).

Photo No.: 5
Orientation: Northwest
Description: Two approximately 20-cubic-yard Scrap Steel Rolloffs located outdoors in the southwest corner of the facility.

Location: SWMU 5
Date: November 18, 1992

Recommendations: Dynamac recommends no further action for the unit at this time.
